## 1234 Sample Street, Bend, Oregon

**Prepared for Mr. and Ms. Client**

**Inspected by Bryan Larson P.E.**

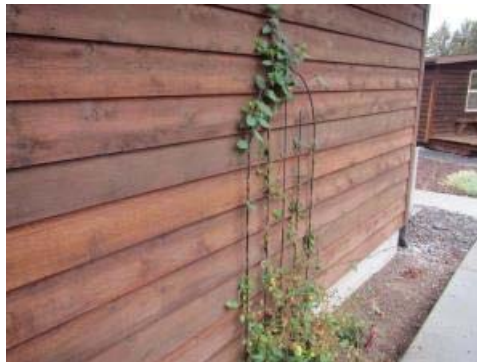
- Good. However:
  - 1) A plant on a trellis was installed against the exterior wall located behind the garage. This plant causes moisture to remain in this area for long periods of time. This is conducive to wood rot and other moisture related conditions. These conditions were not observed in the sampled areas viewed at the time of the inspection. It is recommend that this plant a trellis be removed.

**Plant on Trellis - Exterior Wall - Rear of Garage**

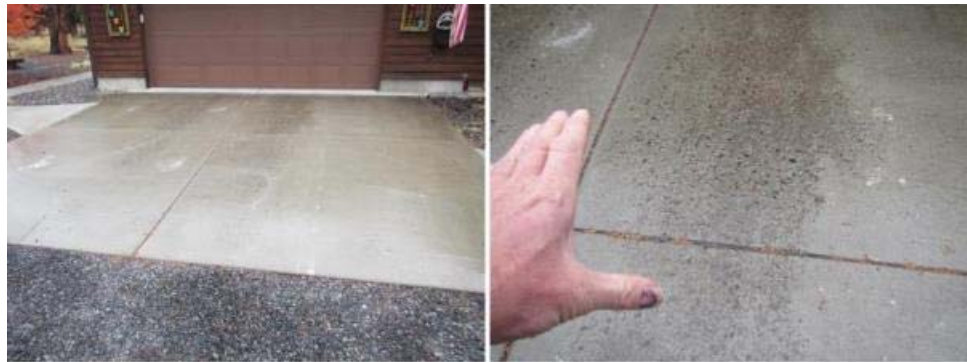
- Asphalt and concrete. Good. However:
  - 1) Spalling was observed on the surface of the concrete. This condition will continue to degrade the concrete over time, particularly during wintertime freeze thaw cycles. If this is a concern, it is recommend that a qualified concrete contractor evaluate and address this condition.
  - Note: Settling cracks were observed in the surface of the concrete in various locations. These cracks were not significant at this time.

Right Image - **Spalling - Sample Area Shown**

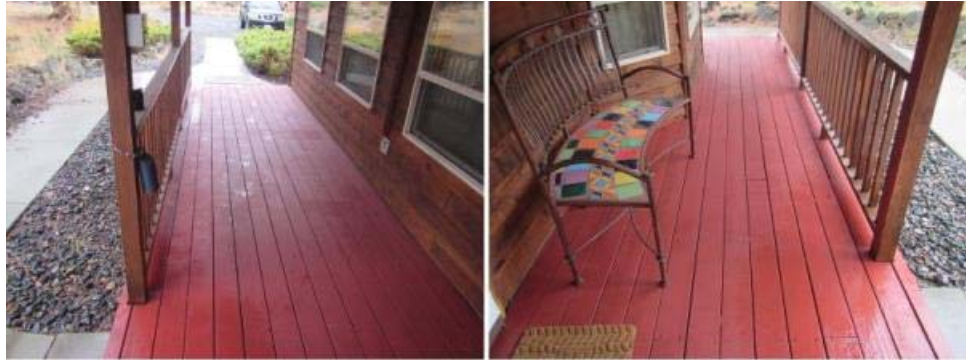
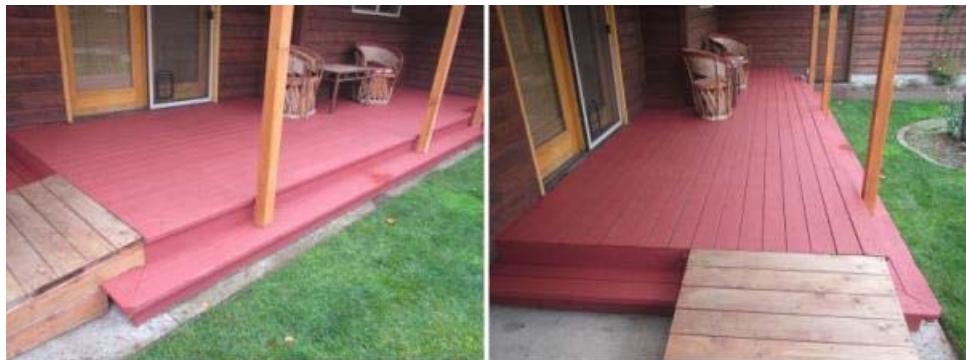
- Good. However:
  - 1) The undersides of both of the front and rear decks were obscured by their low height and skirting and could not be viewed. No indications of structural conditions were detected when walking on the surface of these decks. If this viewing condition is a concern, it is recommend that a qualified contractor temporarily remove several deck planks to determine the condition of the deck substructures.

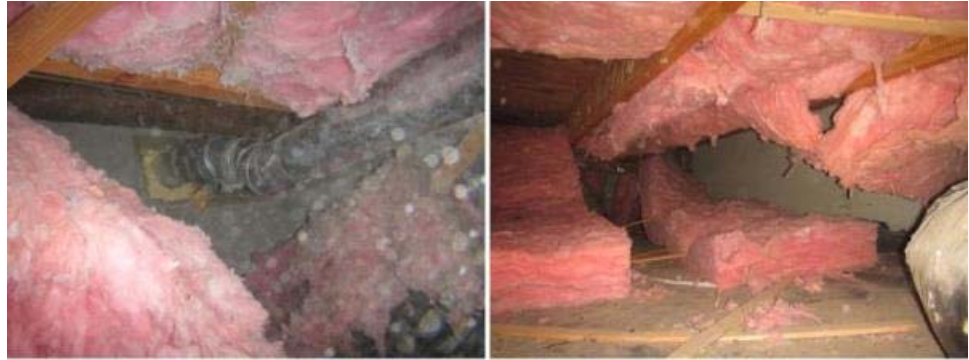
- Good. However:
  - 1) Fallen subfloor insulation was observed in various areas throughout the crawl space. As a result, the effectiveness of the subfloor insulation system was compromised in these areas.

**Fallen Insulation - Various Areas in Crawl Space - Sample Shown**

It is recommend that a qualified contractor evaluate and address this condition.

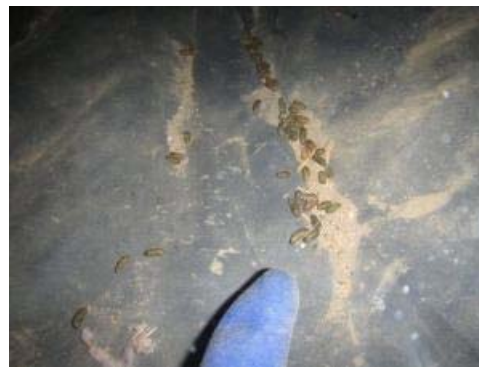
- - 1) Evidence of rodent activity was observed in the crawl space in various locations. Rodent waste, debris piles and damaged subfloor insulation were observed. This limited visual inspection could not determine if this was an active condition. It is recommend that the seller be asked about this condition. Evaluation by a qualified exterminator may also be a consideration.

**Rodent Waste - Sample Shown**

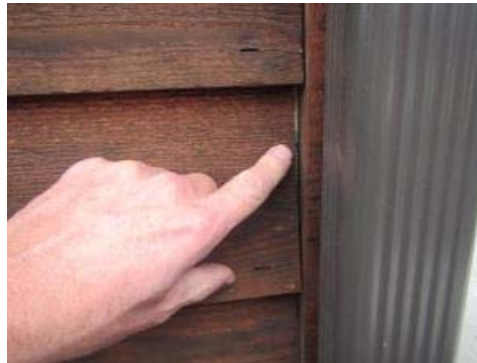
- Good. However:
  - 1) Unsealed gaps were observed at the wood siding and trim abutments on this home in numerous locations. These gaps are necessary to allow for expansion and contraction of the siding during hot and cold temperatures. Should these gaps be sealed with caulking?

The application of caulking in these gaps is a topic of much discussion for siding professionals. Caulking is typically required to be applied to these areas by the siding manufacturers to prevent moisture from entering the area behind the siding. Note that failure to follow the manufacturers installation instructions may void any warranties for this siding.

However, many siding contractors believe caulking is conducive to wood rot as it can trap moisture in these areas. And painters typically do not apply caulking to these abutments due to cosmetic reasons.

Note that the relatively dry climate here in Central Oregon can be rather forgiving with a condition such as this.

**Unsealed Gaps - Siding and Trim Abutments - Sample Area Shown**

It is recommended that this condition be discussed with a siding contract. Examination of the siding manufacturers installation instructions for this particular

brand of siding is also recommended.

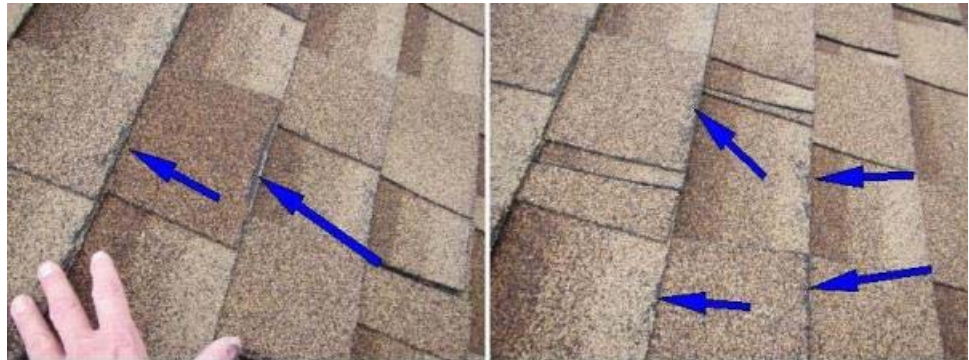
- 5.3 Roof Covering Material: Composition shingles.  
5.4 Roof Access: Walked on roof.  
5.5 Cover Layers: There appeared to be one layer of roof covering. Good.  
5.6 Covering Status: ● Good. However:  
- 1) Granular material was missing from the surface of the shingles in numerous areas. This condition is a normal sign of aging. Good coverage was still present at the time of the inspection. However, the roof covering was nearing the end of its useful life. Evaluation of this condition by a qualified roofing contractor may be a consideration.

**Missing Granular Material Numerous Areas - Edges of Shingles - Sample Areas Shown**

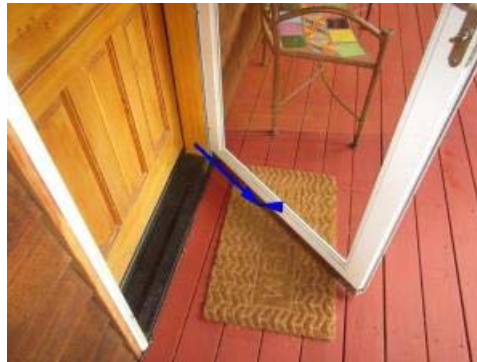
- Good. However:
  - 1) A closing mechanism was expected for the screen door installed on the main entry to the home but none was installed. This condition may allow high wind conditions to damage this screen door. It is recommended that a qualified contractor evaluate and address this condition.

**Closing Mechanism Not Installed - Main Entry Screen Door**

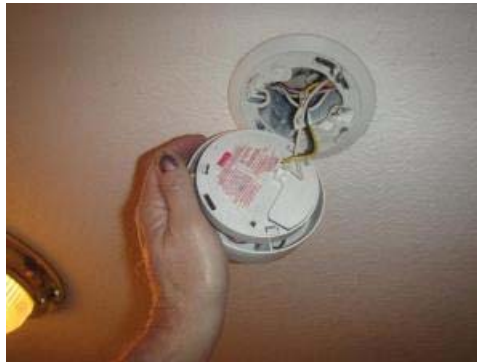
- 7.13 Comments:**
- The hardwired smoke alarm installed on the ceiling on the right side of the home was installed in accordance with Oregon law. This alarm was functional. This alarm was installed in 2014.
    - 1) The hardwired smoke alarm installed on the left side of the home was older than ten years. Oregon law requires that smoke alarms ten years or older must be replaced prior to the transfer of ownership. According to the date stamp, this alarm was manufactured in 1994. This smoke alarm must be replaced prior to the transfer of ownership. Oregon law states that hardwired smoke alarms cannot be replaced with units operated solely by a battery.

**Smoke Alarm Installed on Ceiling of Hallway on Left Side of Home Older than Ten Years**

- 7.13.1 Smoke Alarms - Older than ten years on left side of home - Replace with new prior to transfer of ownership

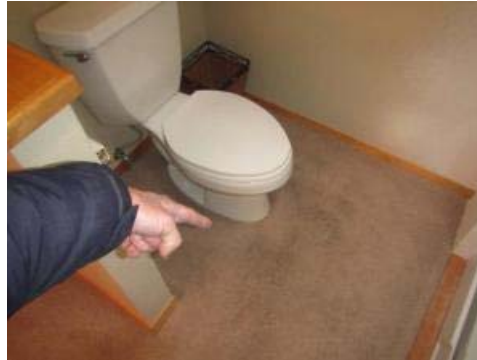
- Good. However:  
- 1) Carpeting was installed around the base of the toilet. This condition is not in accordance with current building practices. This carpeting is considered to be a potential health hazard. This carpeting may also retain moisture for extended periods of time. This is conducive to mold and wood rot.

**Carpeting Installed in Toilet Area**

It is recommended that this carpeting be removed. It is recommended that a qualified flooring contractor evaluate and address this condition.

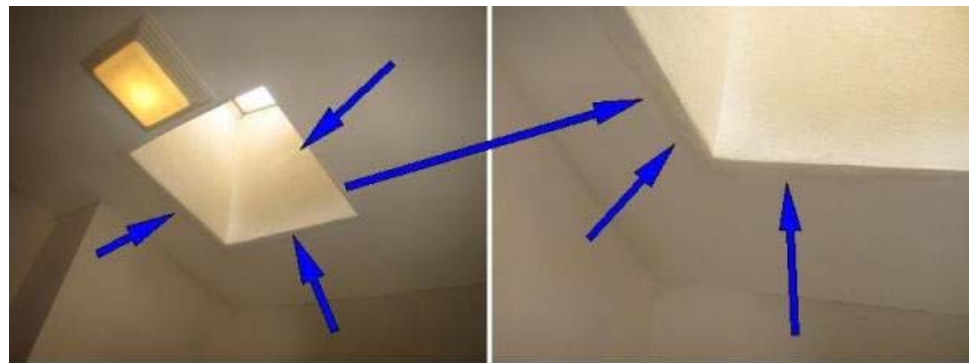
- Good. However:  
- 1) Degraded areas were observed on the drywall located in the lower edges of the skylight tunnel located in the master bathroom. It appeared that this damage may have been caused by moisture.

Based on a visual inspection, it appeared that this moisture was caused by condensation dripping from the underside of the skylight. It was suspected that this condition was most prominent during cold temperatures and hot showers.

**Degraded Finish - Lower Edges of Skylight Tunnel in Master Bathroom**

It is recommended that a qualified drywall contractor evaluate and address this condition.

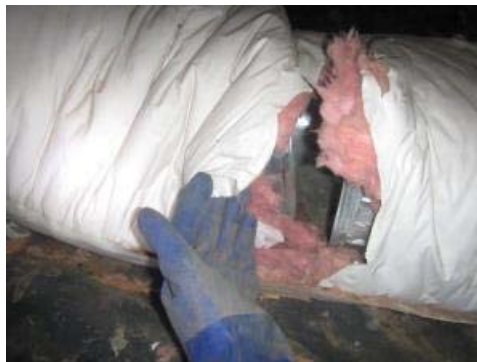
- Good. However:
  - 1) Ductwork was disconnected in at least one location in the crawl space near the crawl space access hatch area. This condition affects the efficiency of the heating and cooling systems in this home. It is recommended that a qualified HVAC contractor evaluate and address this condition.
  - 2) Ductwork was on the ground in the crawl space in several locations. This is not in accordance with standard building practices. Under certain conditions this condition may be conducive to mold and may also be attractive to rodents. It is recommended that a qualified Heating, Ventilating and Air Conditioning (HVAC) contractor evaluate and address this condition.
  - Note: Air flow was detected at all the accessible registers. Determining the adequacy of the air flow through the accessible registers is beyond the scope of this inspection.

**Disconnected Duct Near Crawl Space Hatch Area in Crawl Space**

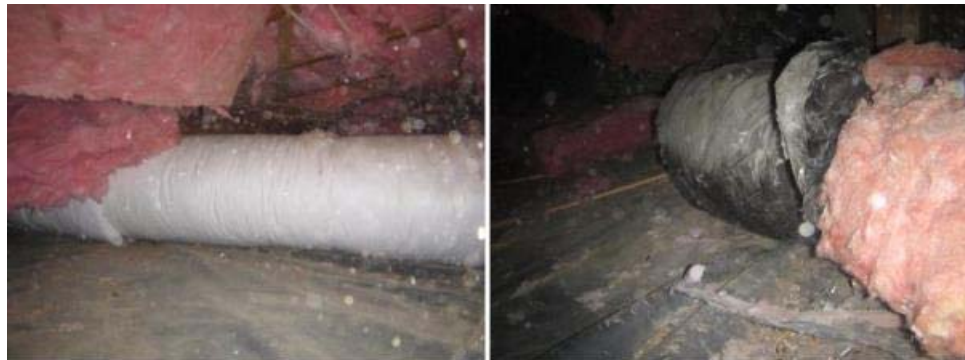
**Ductwork on Ground - Various Areas - Sample Shown**

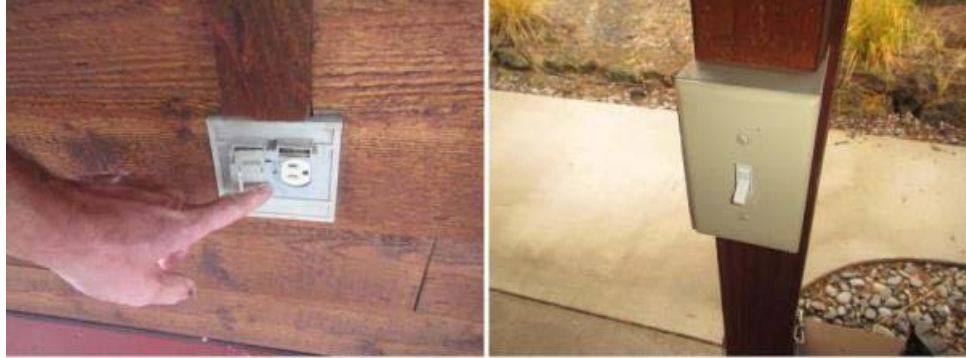
Left Image - **Damaged Weather Rated Cover - Left Front of Home**  
Right Image - **Weather Rated Cover Not Installed - Switch on Front Deck**
