## 1234 Sample Street, Bend, Oregon

**Prepared for Mr. and Ms. Client**

**Inspected by Bryan Larson P.E.**

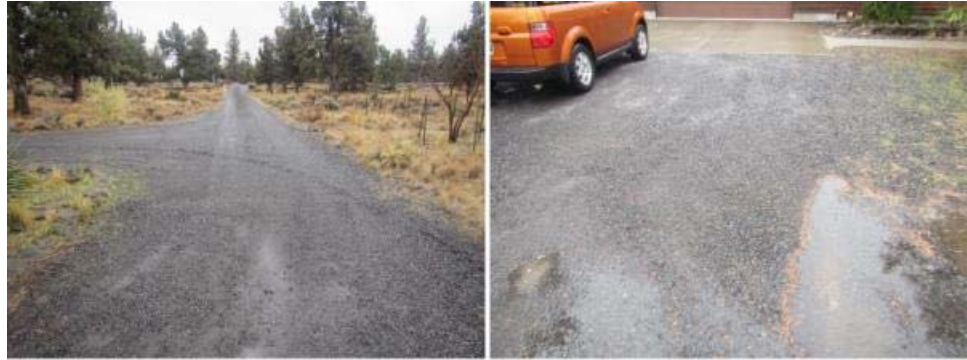
2.5

- Asphalt and concrete. Good. However:
  - 1) Spalling was observed on the surface of the concrete. This condition will continue to degrade the concrete over time, particularly during wintertime freeze thaw cycles. If this is a concern, it is recommend that a qualified concrete contractor evaluate and address this condition.
  - Note: Settling cracks were observed in the surface of the concrete in various locations. These cracks were not significant at this time.

Right Image - **Spalling - Sample Area Shown**

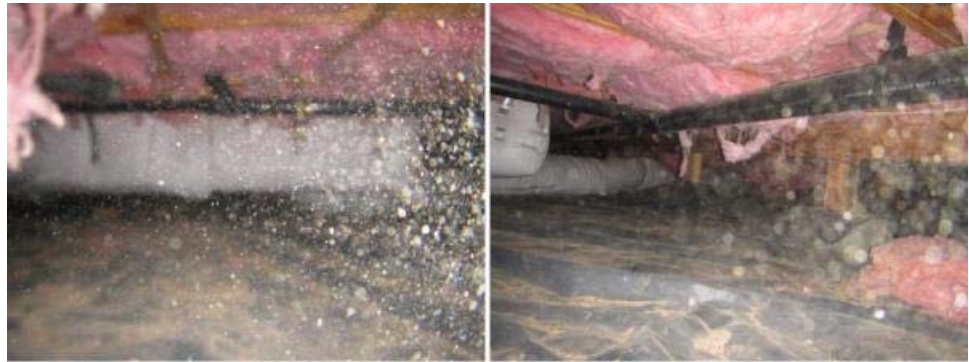
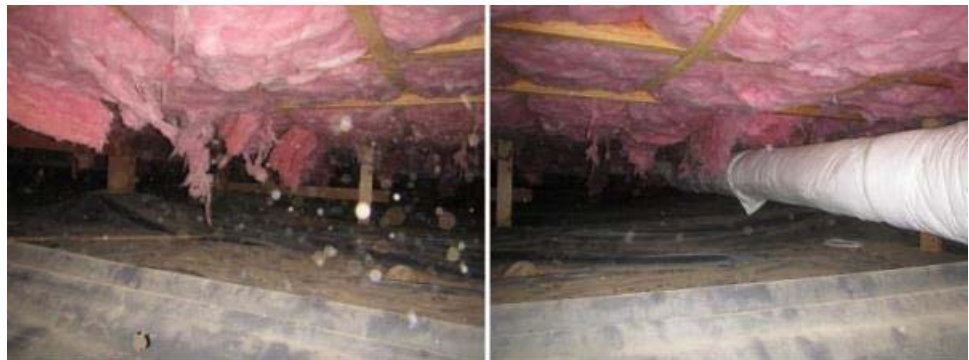
### 3.12

- Good. However:
  - 1) Fallen subfloor insulation was observed in various areas throughout the crawl space. As a result, the effectiveness of the subfloor insulation system was compromised in these areas.

- - 1) Evidence of rodent activity was observed in the crawl space in various locations. Rodent waste, debris piles and damaged subfloor insulation were observed. This limited visual inspection could not determine if this was an active condition. It is recommend that the seller be asked about this condition. Evaluation by a qualified exterminator may also be a consideration.

**Crawl Space - Sample Areas Shown**

It is recommend that a qualified contractor evaluate and address this condition.

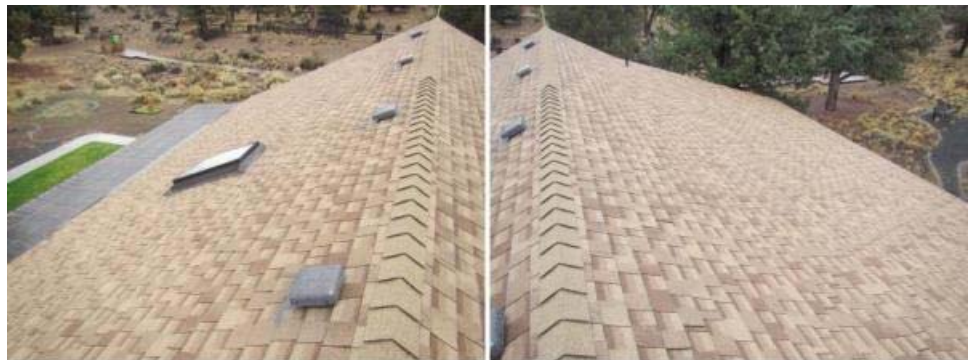
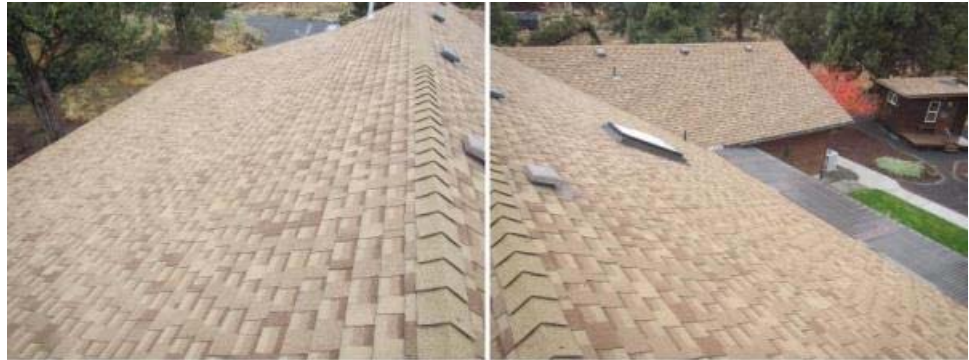
5.7

- 5.3 Roof Covering Material: Composition shingles.  
5.4 Roof Access: Walked on roof.  
5.5 Cover Layers: There appeared to be one layer of roof covering. Good.  
5.6 Covering Status: ● Good. However:  
- 1) Granular material was missing from the surface of the shingles in numerous areas. This condition is a normal sign of aging. Good coverage was still present at the time of the inspection. However, the roof covering was nearing the end of its useful life. Evaluation of this condition by a qualified roofing contractor may be a consideration.

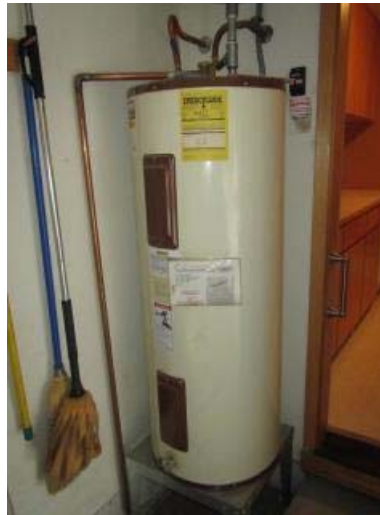
**10.13**

- Good. However:
  - 1) The average life of a water heater in the United States is between 8 and 12 years. However, due to the high quality of the water supply in Central Oregon, water heaters 25 to 30 years old are not uncommon in this area. Please note that this heater may fail at any time. If this is a concern, recommend a qualified plumbing contractor install a new unit.
  - Note: The Temperature Pressure Relief (TPR) valve was observed as expected. TPR valves are not operated as this safety device may be subject to leakage if activated.
